Manhole Inspection Summary

Manhole # S43II_010MH

Insp Date: **3/11/08 9:56 AM**

Location Address: **1622 BETHEL ST**

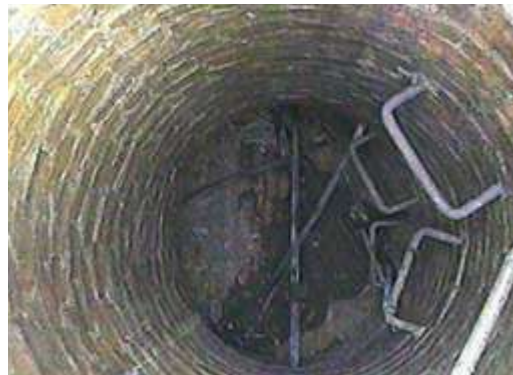
Defect 2

Condition: ☐ Sound ☐ Cracked ☐ Root Intrusion ☐ Deteriorated ☐ Leaks ☒ **Debris**

DEBRIS

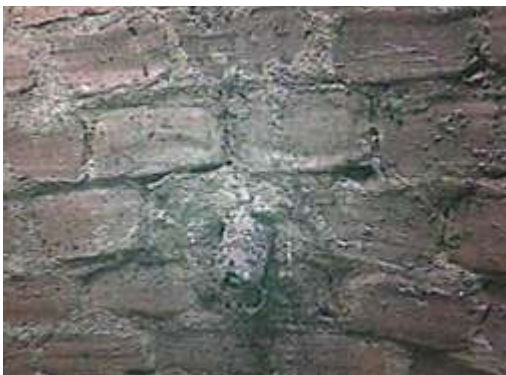
Defect 1

POSSIBLE ILLICIT CONNECTION

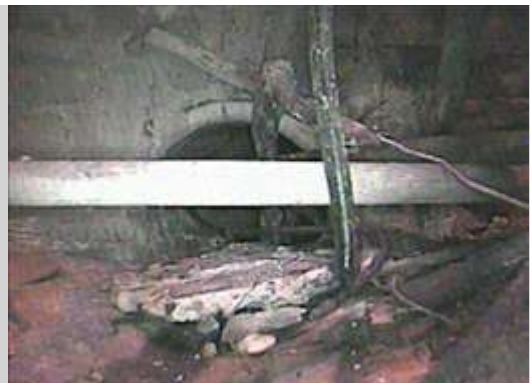
12 O'Clock Outflow

LOTS OF DEBRIS
